**HISTORIC PROPERTIES MANAGEMENT PLAN COMPLIANCE REPORT
PIT 1 GATEHOUSES OVERHAUL PROJECTS
SHASTA COUNTY**

FERC PROJECT No. 2687

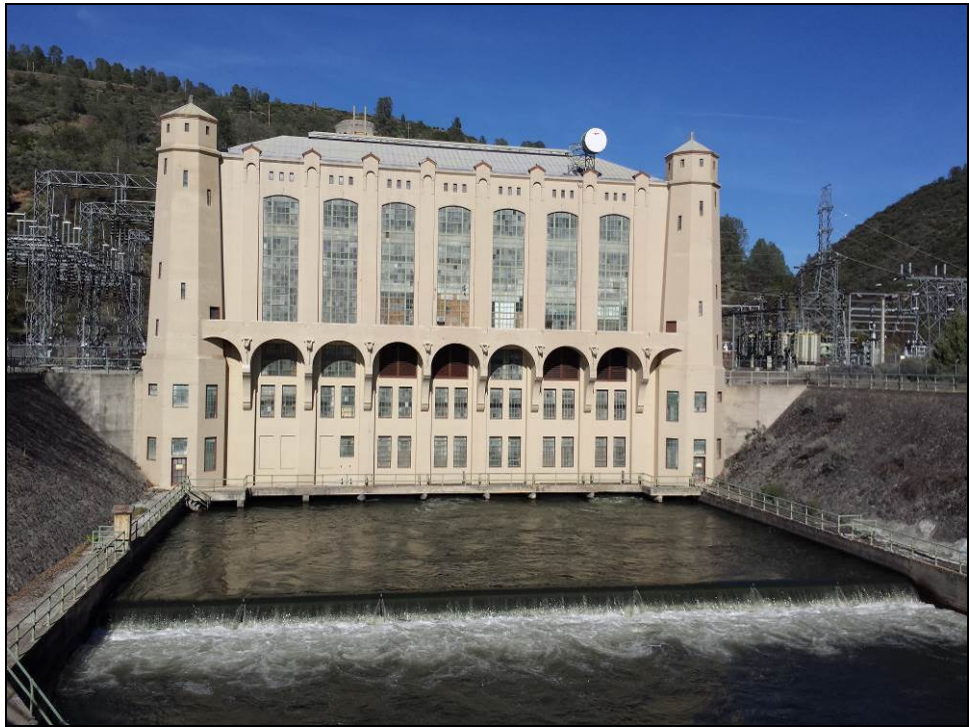
Figure 2: Pit 1 Powerhouse. Other components of the Pit 1 Hydroelectric System are architecturally unified around this highly stylized Gothic Revival edifice.

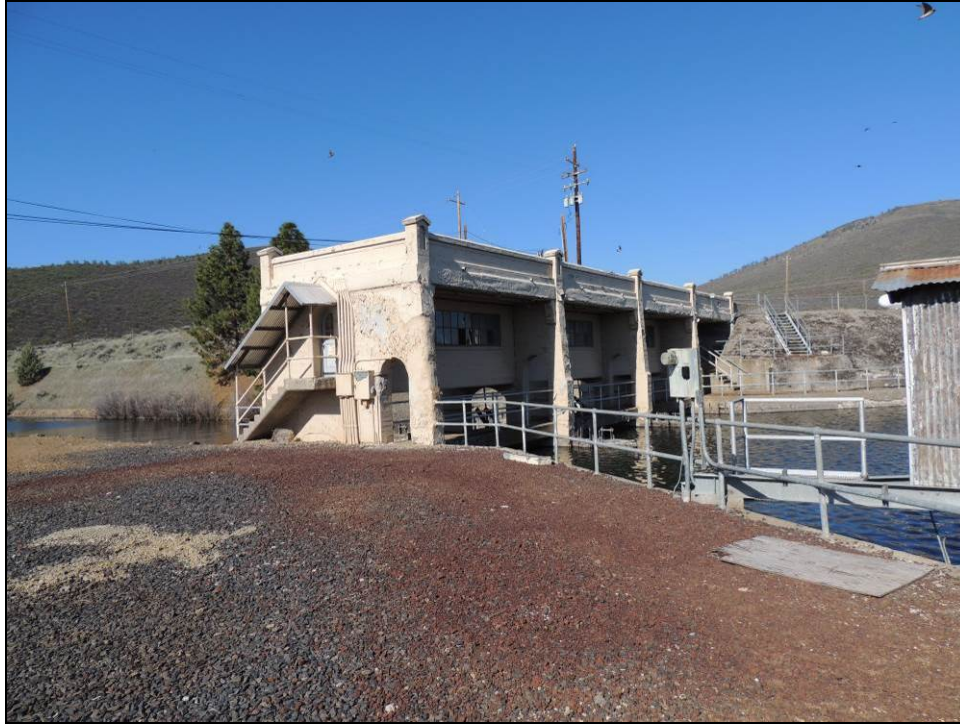
Figure 5: Gatehouse 9-10-11, April 2014, prior to restoration. Structure ceased serving as a bridge in 1946-47 when south end (left) was modified.

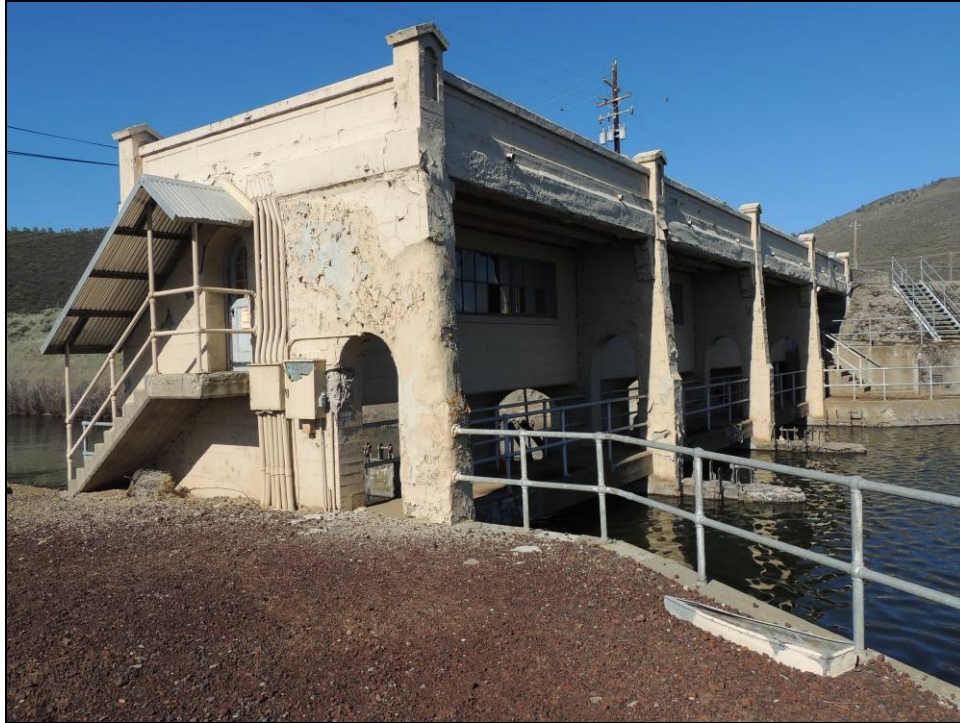
Figure 6: Pit 1 Gatehouse 9-10-11, April 2014. Note concrete spalling on exterior façade.

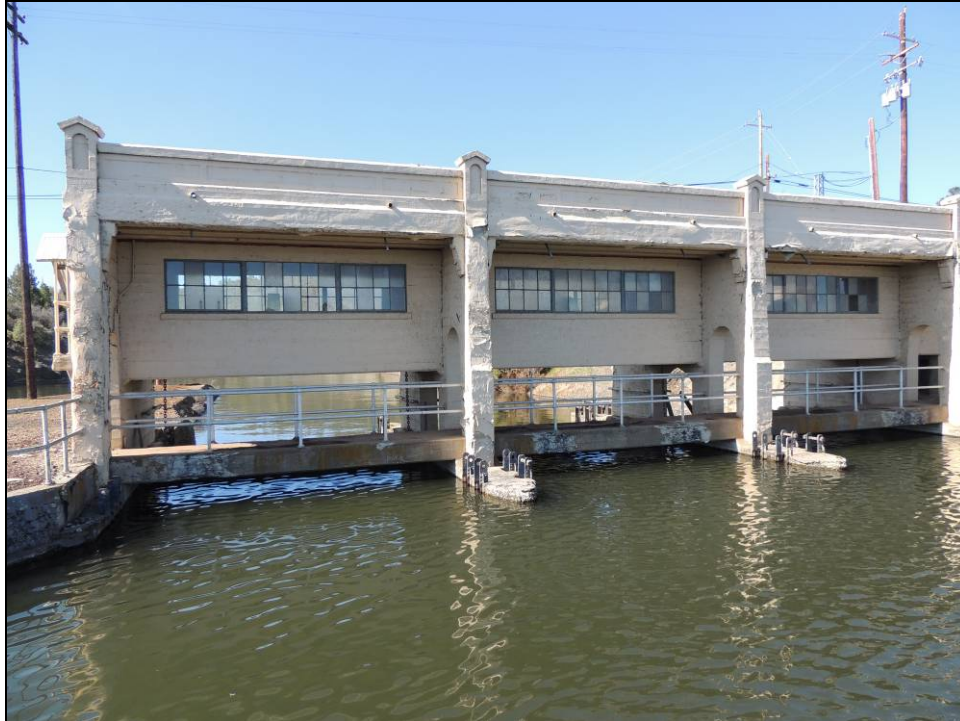
Figure 7: North side, Pit 1 Gatehouse 9-10-11, April 2014.

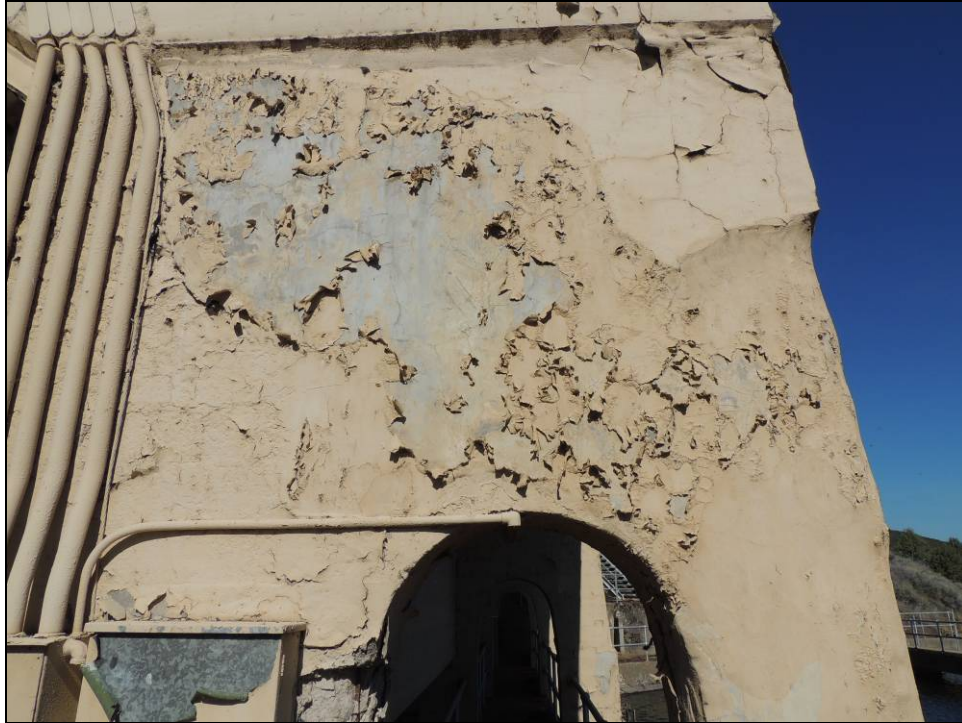
Figure 8: Detail view of concrete spalling on northeast corner of Pit 1 Gatehouse 9-10-11, April 2014.

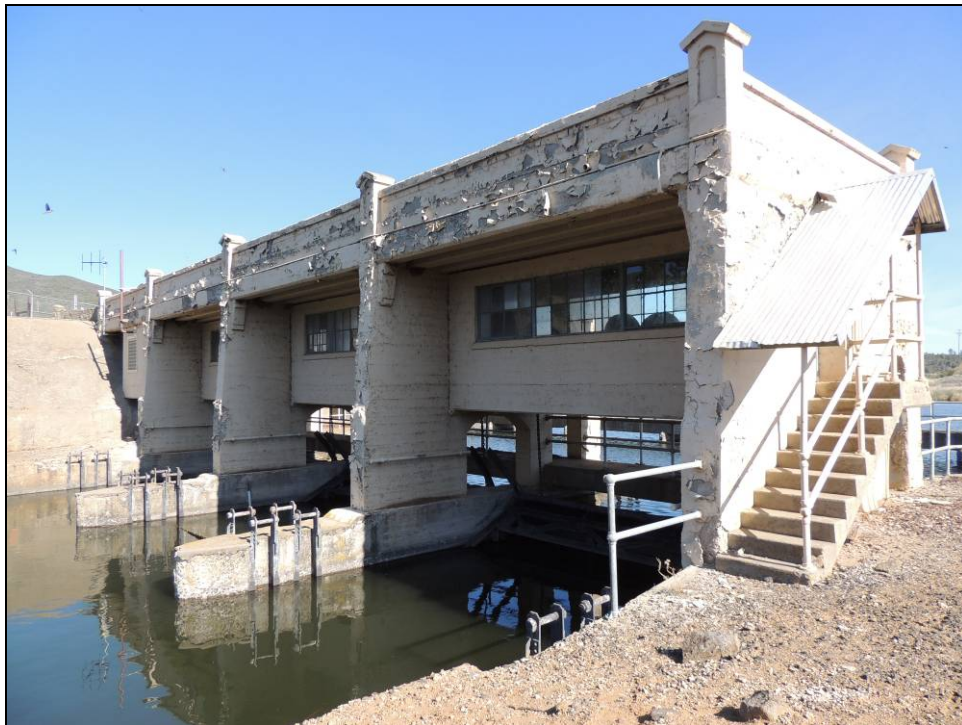
Figure 9: Pit 1 Gatehouse 9-10-11, April 2014. Note concrete spalling along exterior of former bridge deck.

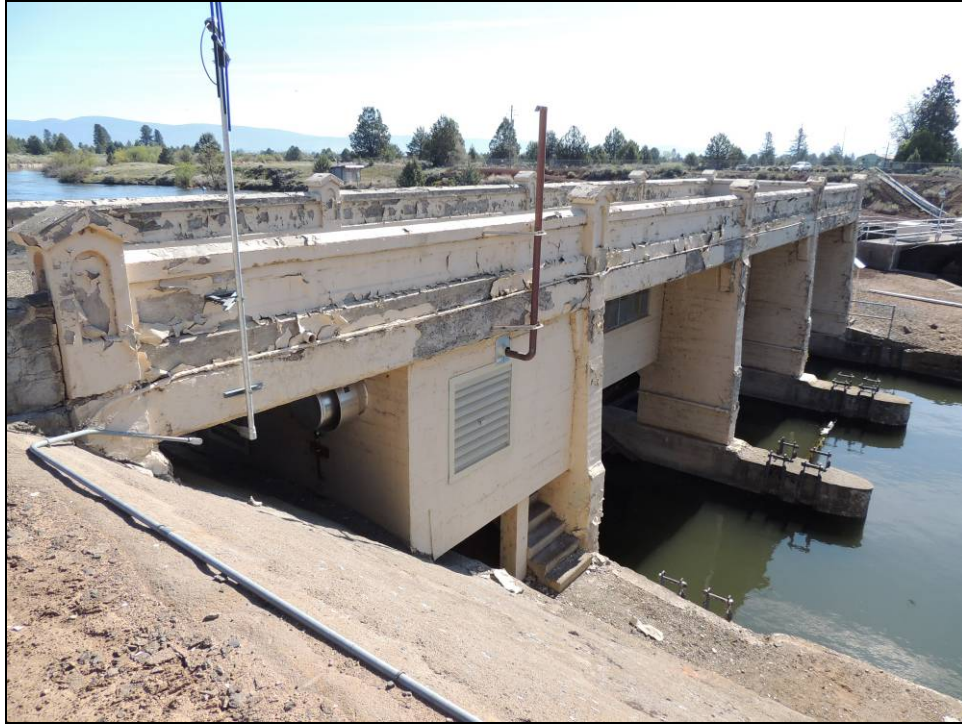
Figure 10: Pit 1 Gatehouse 9-10-11, April 2014.

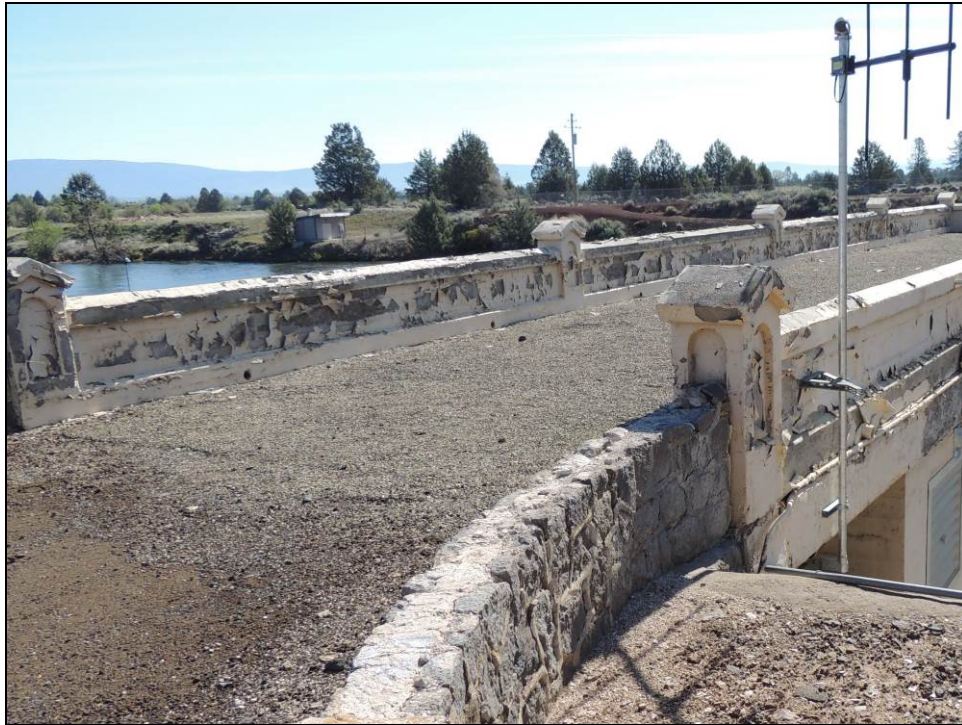
Figure 11: Pit 1 Gatehouse 9-10-11, April 2014. Note extensive degradation and peeling along interior retaining walls of former road deck.

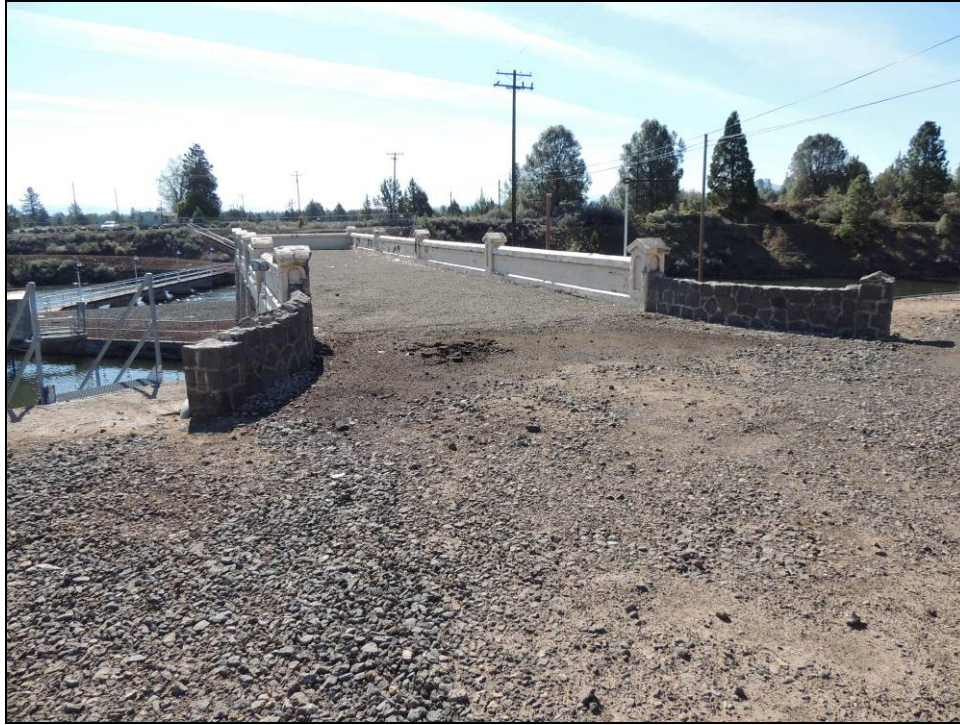
Figure 12: Remaining bridge approaches on west side of Pit 1 Gatehouse 9-10-11, April 2014. Note deteriorated ornamental end caps on stone approaches.

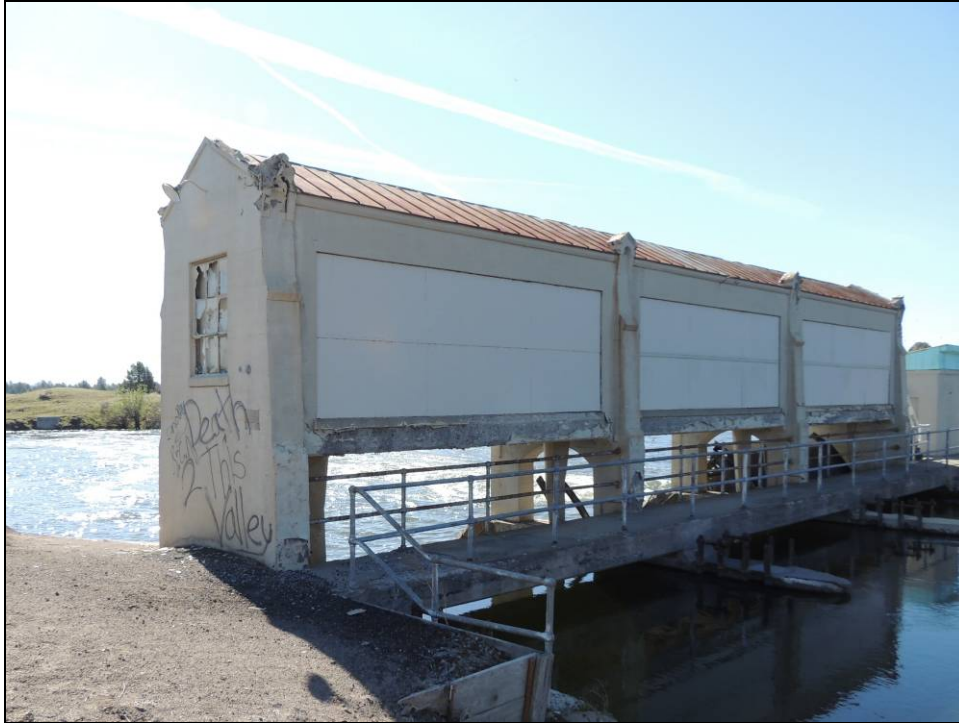
Figure 13: Pit 1 Gatehouse 1-2-3, April 2014. Note covered window bays, broken window panes, and heavily deteriorated window sills and ornamental pinnacles.

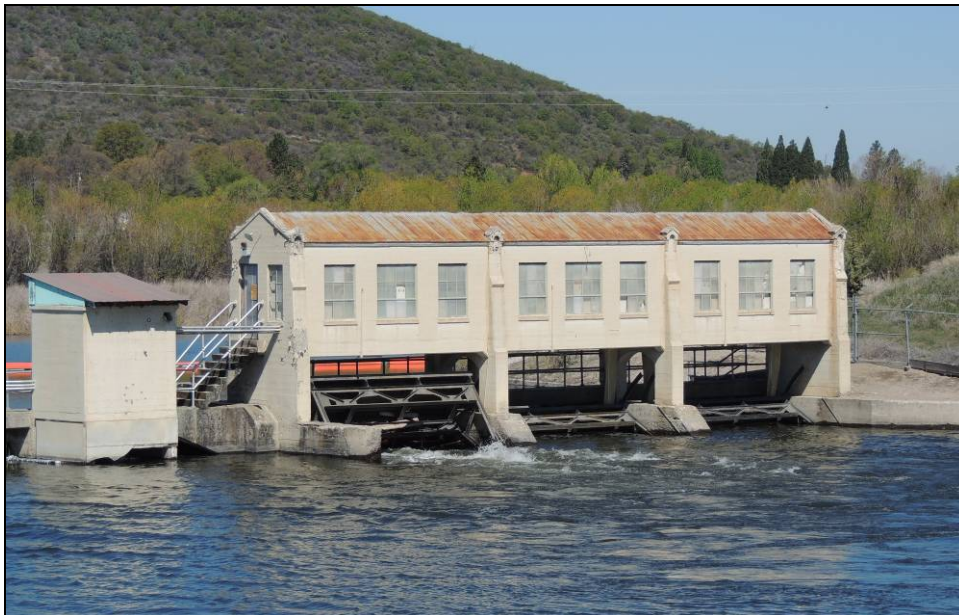
Figure 14: Pit 1 Gatehouse 1-2-3 at right and Float House at left, April 2014. Note roof addition on Float House and replaced window panes on gatehouse.

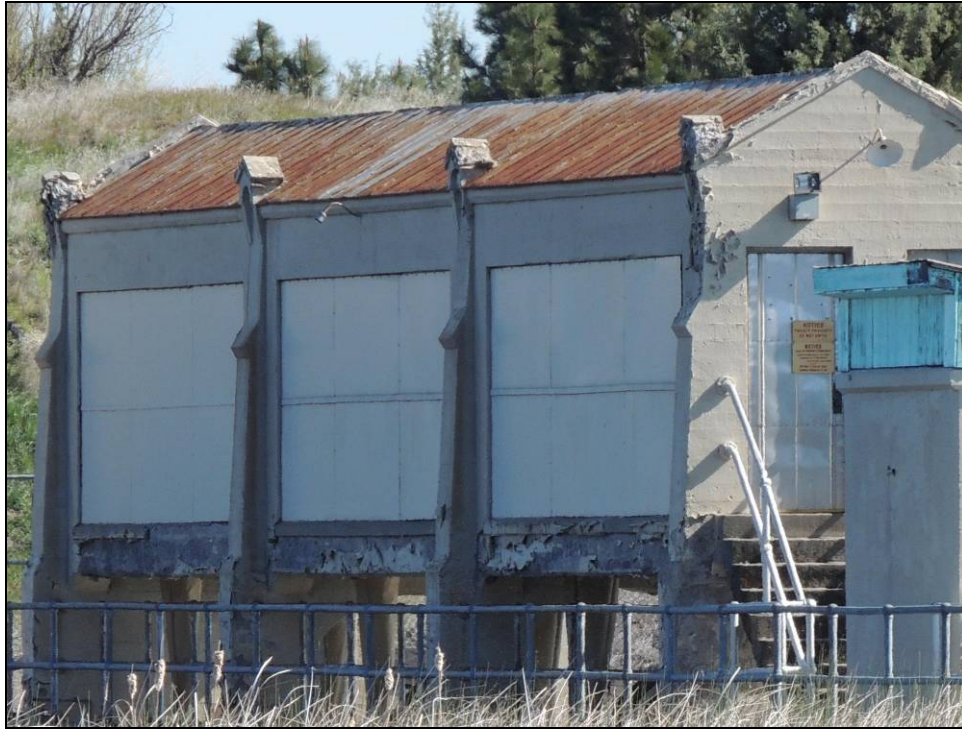
Figure 15: Pit 1 Gatehouse 1-2-3, April 2014. Note significant spalling of ornamental concrete pinnacles at roofline, and at and below sills, covered windows and deteriorating tin roof.

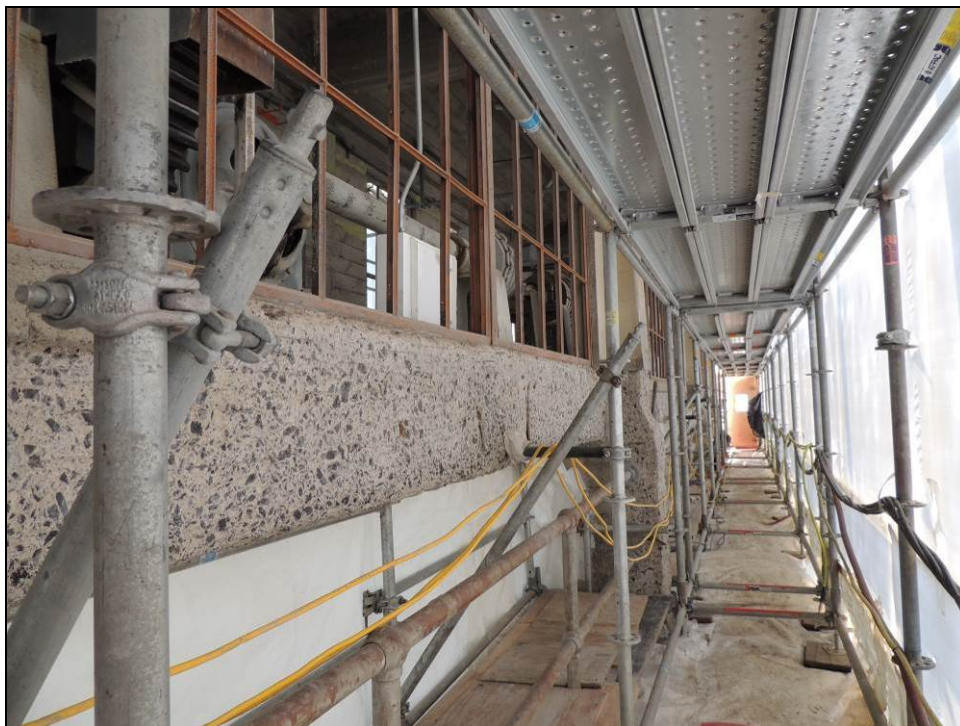
Figure 16: Deteriorated concrete removed from upstream side Gatehouse 1-2-3; glazing removed from steel sash windows, November 18, 2015.

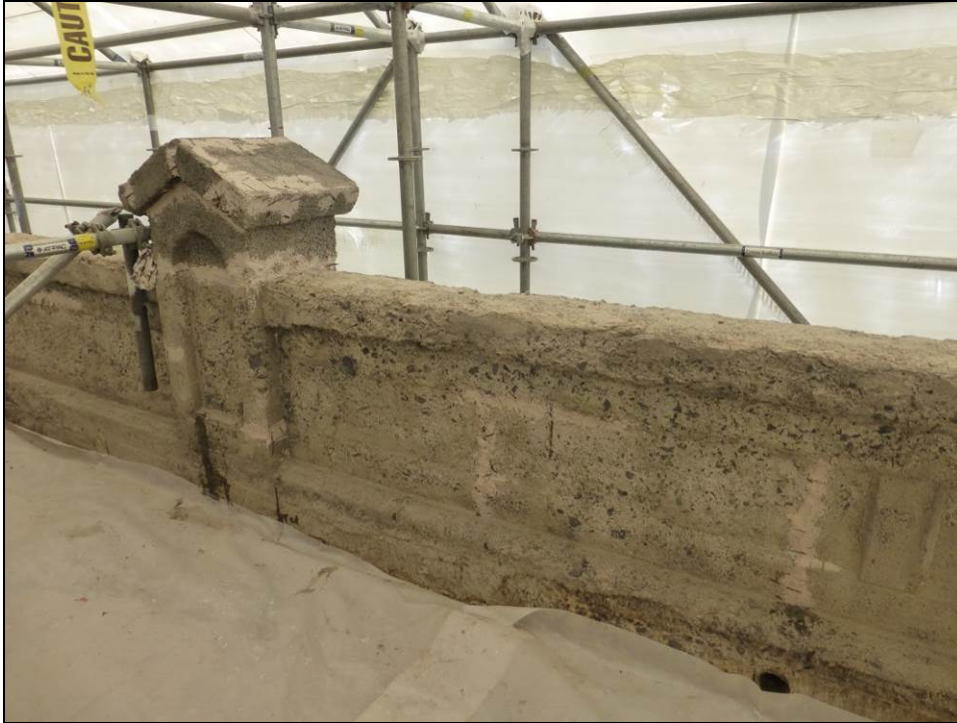
Figure 17: Section of upper level of Gatehouse 9-10-11 that has been subject to dental removal of degraded concrete, May 19, 2016.

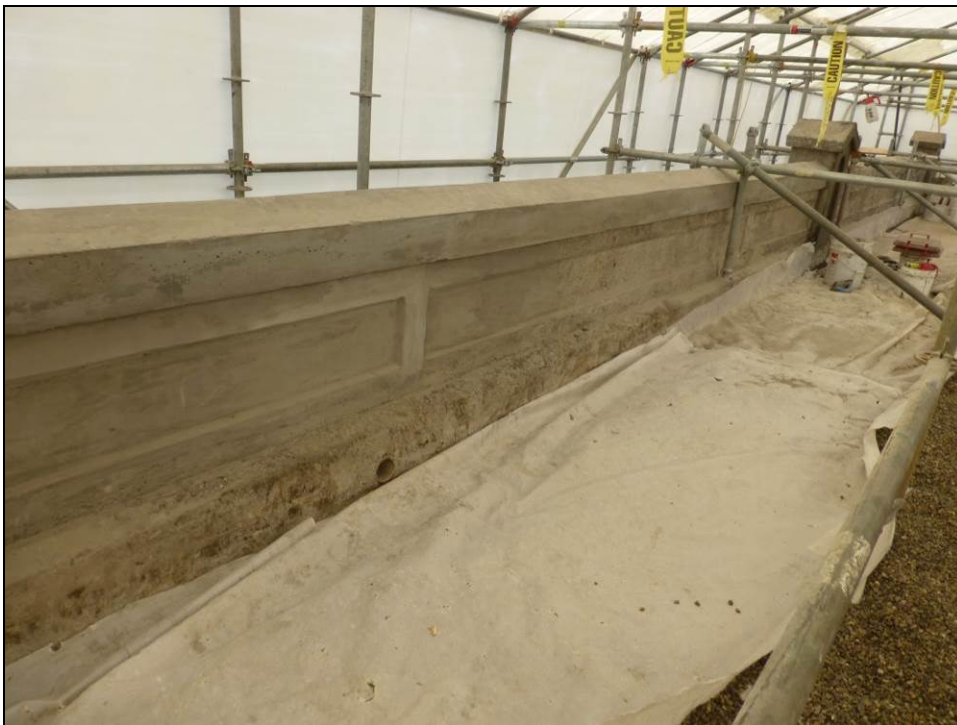
Figure 18: Section of upper level of Gatehouse 9-10-11 nearing completion of reconstruction (see **Figure 16**), May 19, 2016.

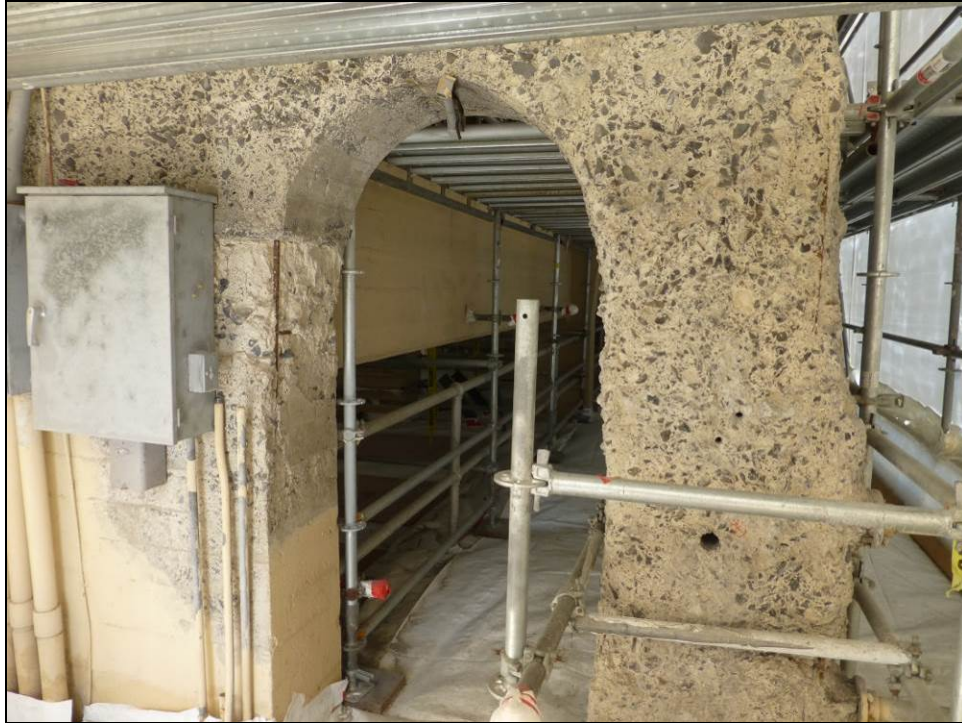
Figure 19: Heavily degraded column on east end of upstream side of Gatehouse 9-10-11 after dental removal of deteriorated concrete, May 19, 2016.

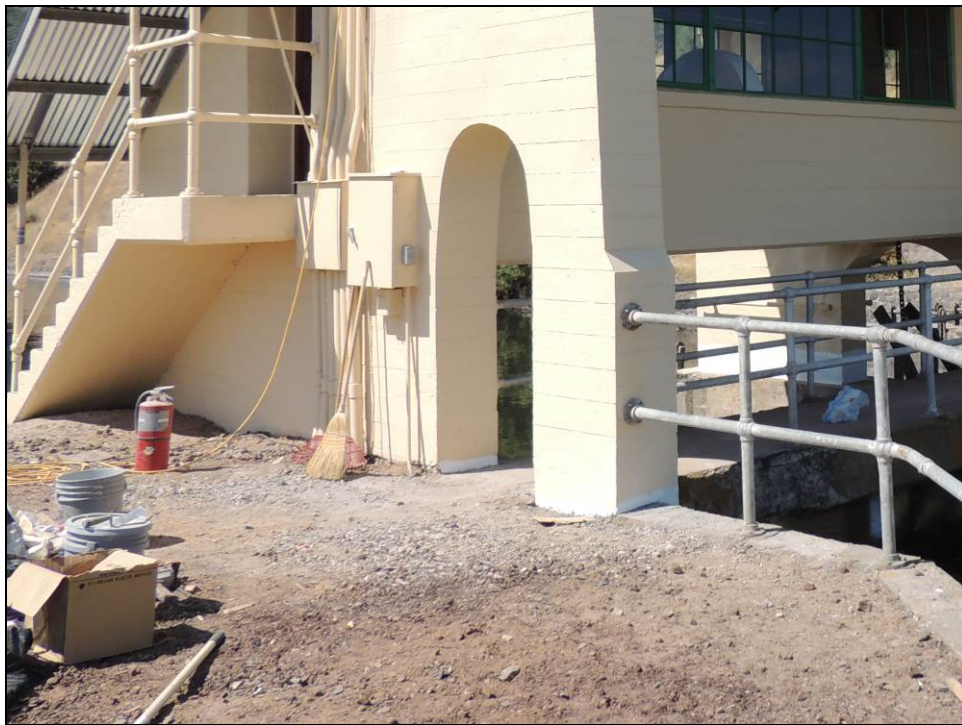
Figure 20: Reconstructed column (see **Figure 18**) on east end of upstream side of Gatehouse 9-10-11, August 16, 2016.

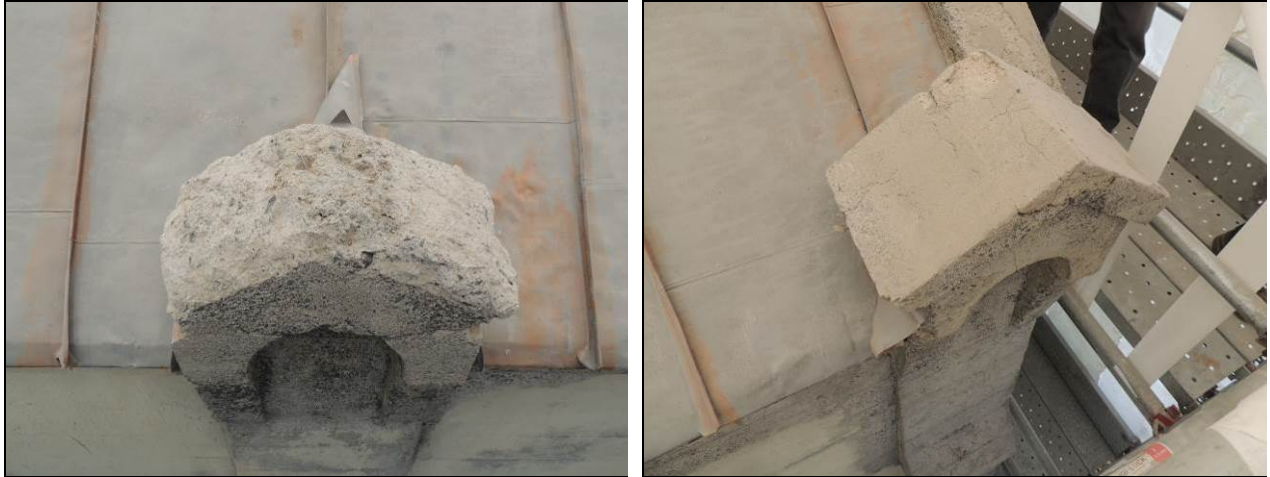
Figure 21: Ornamental pinnacle at Gatehouse 1-2-3 after deteriorated concrete removed at left; intact pinnacle at Gatehouse 1-2-3 used for mold at right.

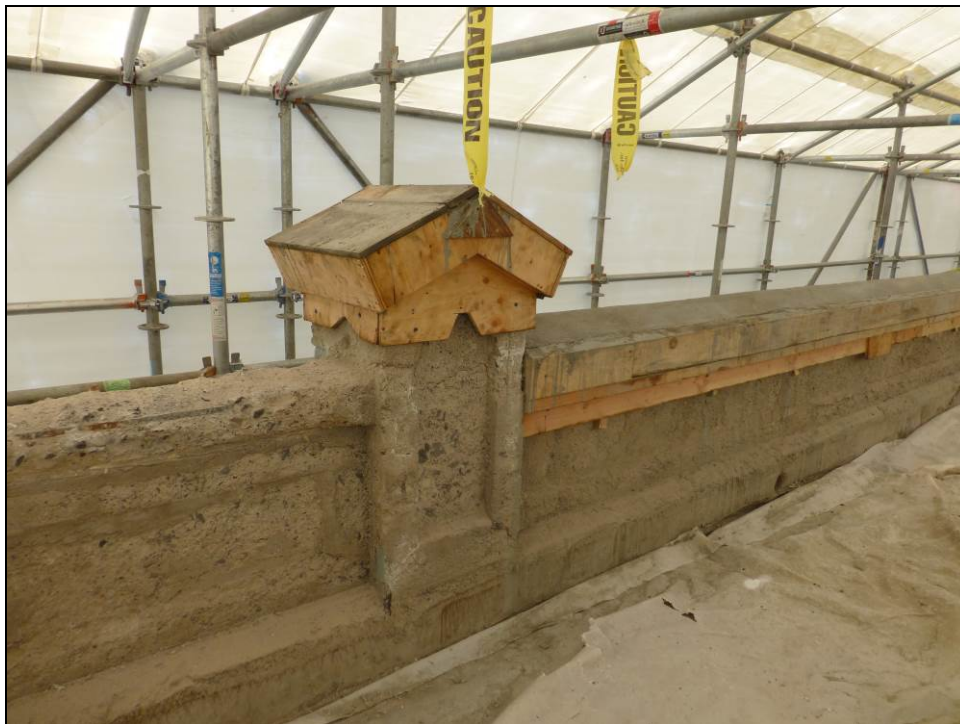
Figure 22: Wood form used to reconstruct ornamental pinnacles and railing details at Gatehouse 9-10-11, May 18, 2016.

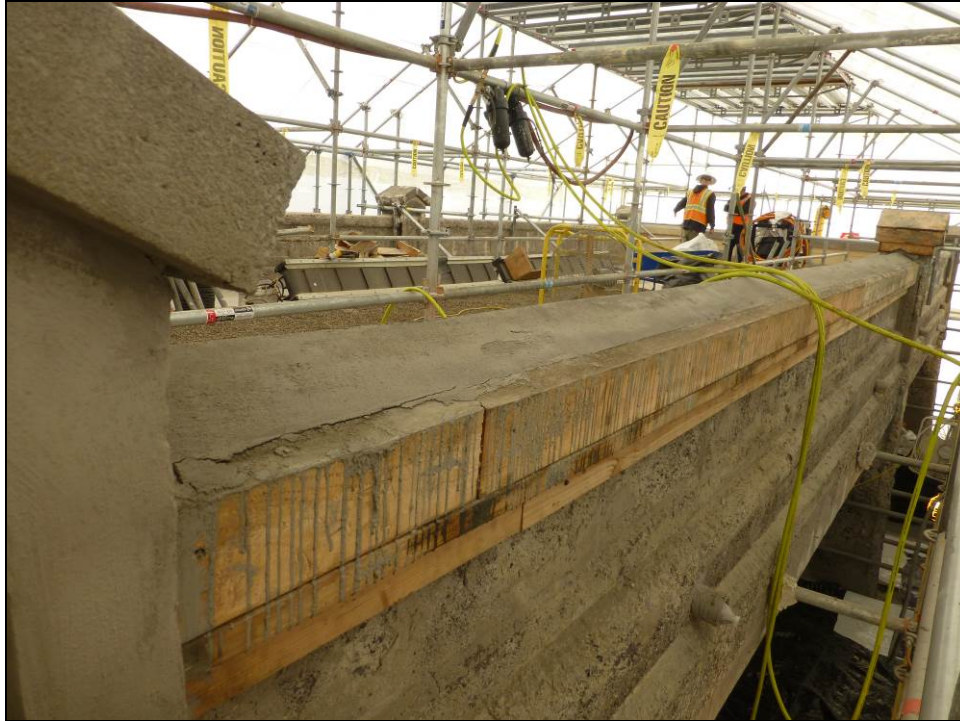
Figure 23: Additional wood forms used to reconstruct architectural detail on railings, May 18, 2016.

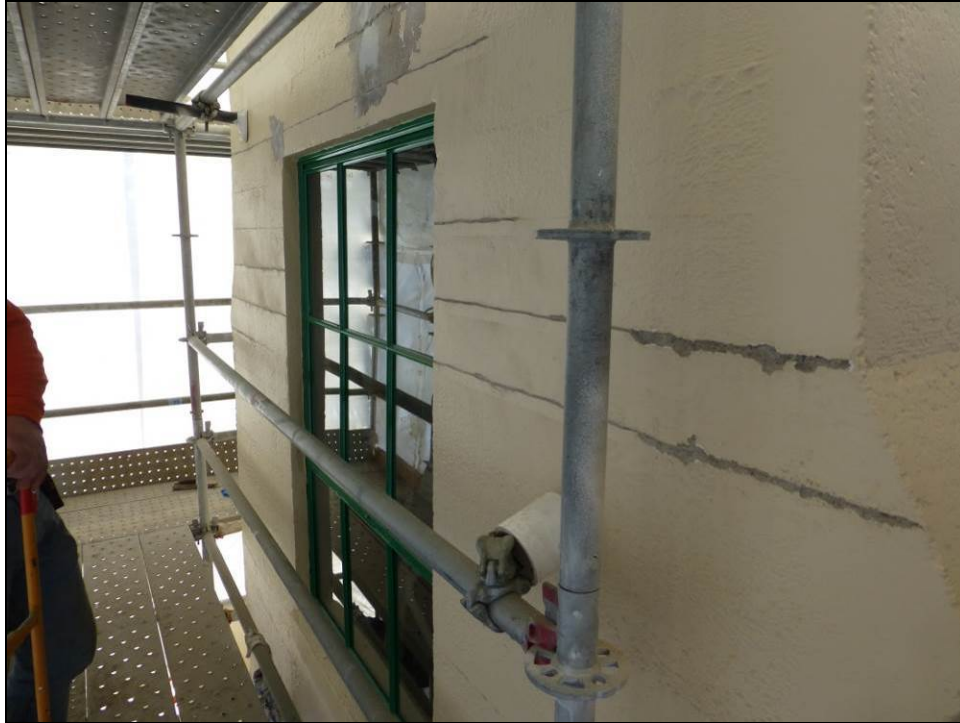
Figure 24: Trial area where AST has applied indentations to restore the horizontal appearance of board-form impressions in the concrete, January 27, 2016.

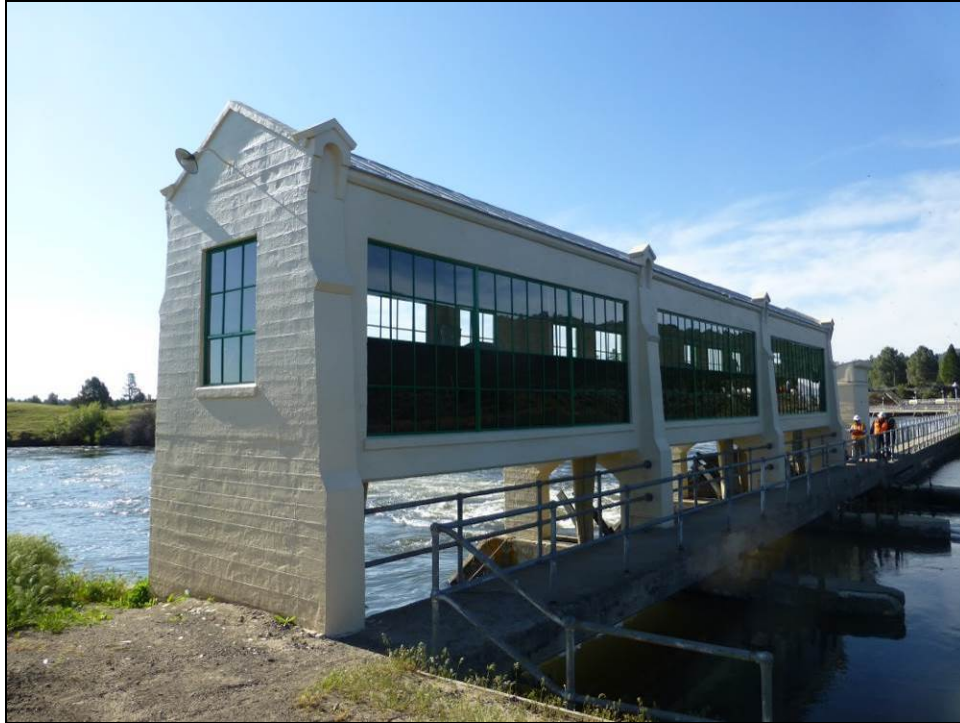
Figure 28: Pit 1 Gatehouse 1-2-3, May 19, 2016. Note that laminated glass windows provide security while allowing visibility through building. Also note reflection of light off rows with black film at far right.

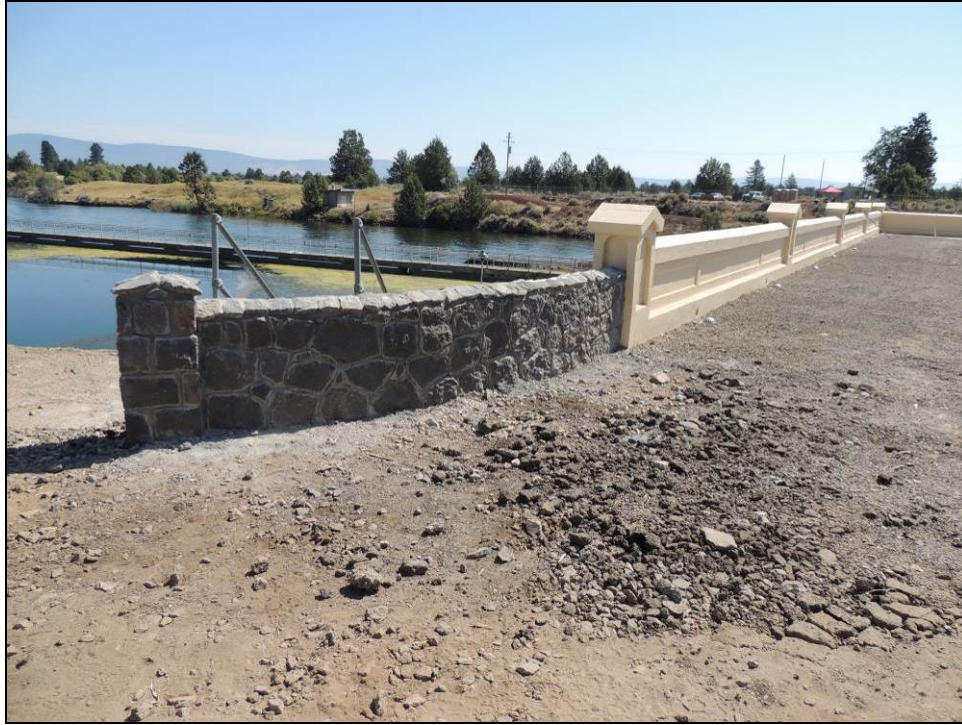
Figure 37: Reconstructed stone approach on west end of Gatehouse 9-10-11, August 16, 2016.
